Condition & Value Survey

Report on

1990 Hylas 44

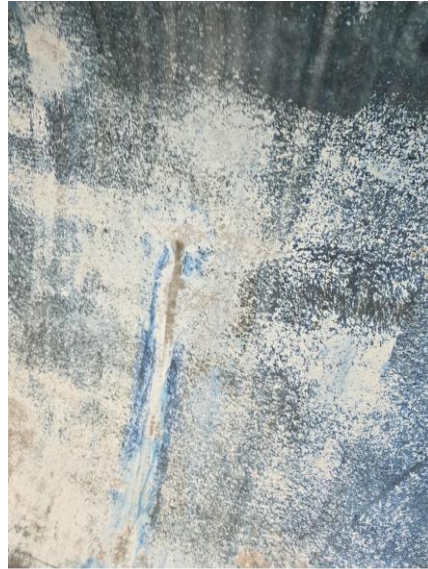
§3.1.6.3

3.1.6.3. The hull-to-keel joint shows no separation from the hull. There is no sign of flexing, and sounding of the laminate forward and aft of the keel does not indicate delamination. Three points on the starboard side show small pinpoints of failed compound and rust streaks, suggesting possible degradation of the bedding compound.

RECOMMENDATION R-12 (Priority II): Dropping the keel to inspect the condition of the bedding compound and keel bolts is recommended at the next available haulout.

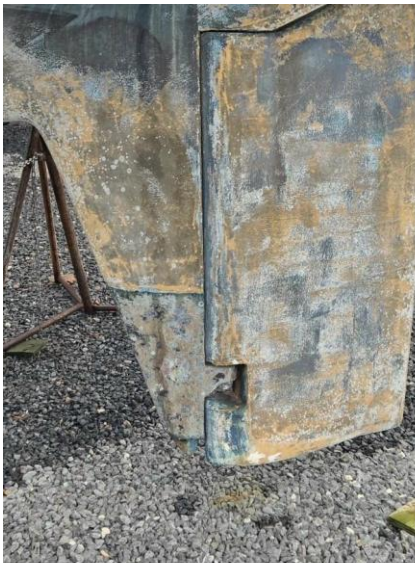
§3.1.7.1

3.1.7.1. The vessel mounts a full unbalanced skeg rudder with a GRP blade built around a stainless steel stock, resting on a bronze boot. The rudder moves freely by hand. No signs of damaged fiberglass in the front part of the skeg or stress cracks between the skeg and the fiberglass were observed. The bronze boot appears serviceable, although some pink discoloration is visible between the sanded protective covering. The rudder presents no holes or streaks across the blade and no signs of impact. Sounding of the rudder was uneven in the upper part of the blade, suggesting either a specific hollow design or possible delamination.

RECOMMENDATION R-13 (Priority II): Further cleaning and inspection of the rudder boot are recommended to check for dezincification and corrosion.

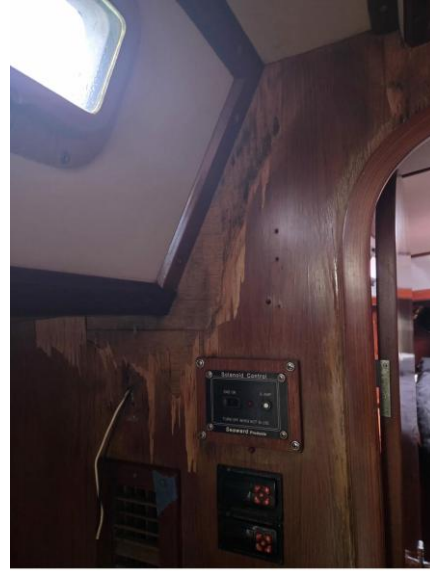
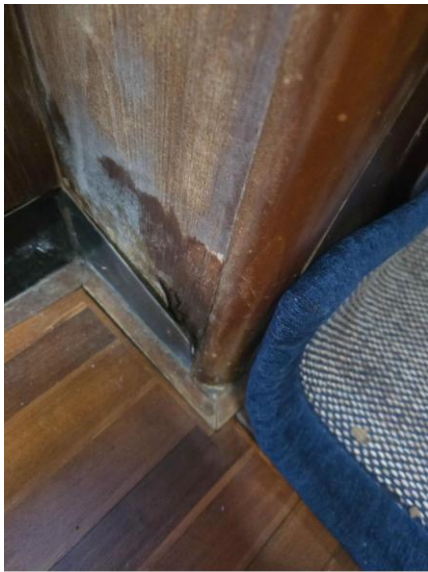
§3.2.3.1

3.2.3.1. The bulkheads were tabbed to the hull with glass cloth. Both the forward and aft bulkheads show signs of water penetration. The port side of the forward bulkhead had a section of approximately 2' x 3' rebuilt with new plywood jointed into the bulkhead. The central bottom section of the same bulkhead, between the end of the port settee and the forward cabin access, shows evidence of rot and loss of material. A stainless steel plate has been nailed to the bulkhead, but some fasteners have lost adhesion. The starboard side of the aft bulkhead between the galley and the aft cabin shows signs of water penetration, with veneer peeled off. The plywood shows signs of water penetration but no loss of material.

RECOMMENDATION R-16 (Priority II): A comprehensive inspection of all bulkheads, including material sampling in damaged areas, is strongly recommended prior to purchase.

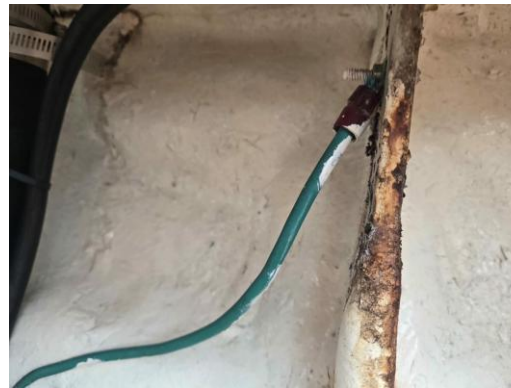
§3.3.2.7

3.3.2.7. There are three large lockers at the stern of the deck. All covers are molded fiberglass with stainless steel latches and hinges, flush with the deck. No standing water was noted inside the lockers and all scuppers appeared clear and operational. The center locker contains the backstay chain plate, laminated to both the deck and hull. The visible part of the plate shows surface corrosion, with paint peeled from most of the plate surface and a streak of rust visible. No pitting was noted on the metal.

RECOMMENDATION R-18 (Priority II): Further inspection for crevice corrosion on the backstay chain plate is recommended, including removal of paint and inspection of all fasteners.

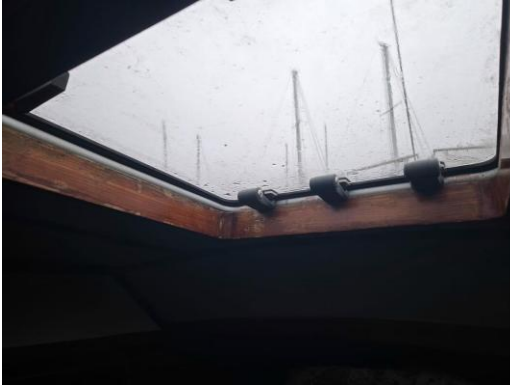
§3.3.3

3.3.3.5. Both smaller side hatches positioned on either side of the mast were inspected. The starboard hatch showed sealant applications and evidence of leaking at the inside trim.

3.3.3.6. The aft trunk cabin hatch showed evidence of leaking at the inside trim.

RECOMMENDATION R-19 (Priority II): Investigation and rebedding of all affected hatches is recommended to eliminate confirmed water ingress at the forward deck hatch, forward trunk hatch, starboard side hatch, and aft trunk hatch.

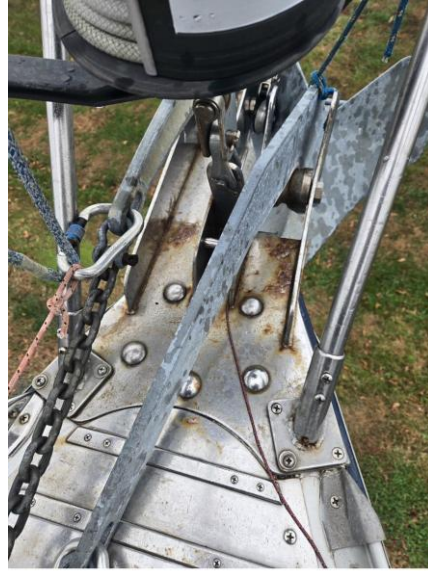
§3.4.3.1

3.4.3.1. The forestay chain plate is fastened with ten carriage bolts — five through the deck and five through the stem. The bases of the forwardmost bow pulpit stanchions are also fastened through this plate, which also acts as an anchor plate. Indentations have caused some corrosion on the forward part. Corrosion and stress cracks are visible on some welds of the anchor plate, and rust streaking is visible around several carriage bolt heads. At the time of inspection the structural integrity appeared sound.

RECOMMENDATION R-22 (Priority II): Further investigation of the forestay chain plate is recommended, including inspection of all fasteners and welds.

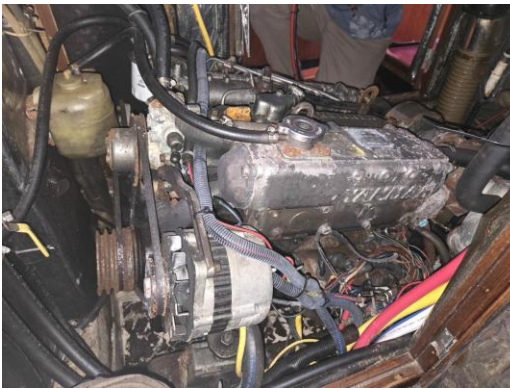
§3.5.1.3

3.5.1.3. The overall condition of the engine showed significant surface corrosion and salt deposits on the block, exhaust manifold, and ancillary components, consistent with the age of the vessel. While no oil or coolant leaks were confirmed, the general state of the engine made a reliable assessment of leak-free condition difficult.

RECOMMENDATION R-05 (Priority I): A full engine running test and oil sampling analysis are strongly recommended prior to purchase and prior to returning the vessel to service.

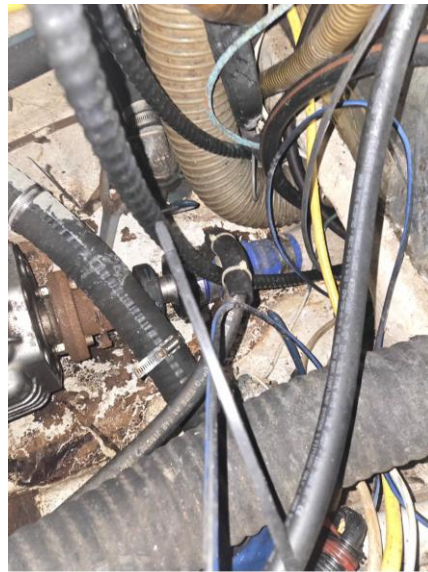
§3.5.3.2

3.5.3.2. The shaft coupler showed heavy corrosion.

RECOMMENDATION R-07 (Priority I): The shaft coupler must be inspected and replaced as necessary prior to use.
